Slope Stability Problems Related to a Semi-Bridge Construction

SYNOPSIS: In the area of "AKTEA", a summer-housing estate 36 Km away from the city of Athens, a great landslide affected the stability of a semi-bridge, constructed in 1980 for the widening of the nearby national road. Preliminary studies carried out before the semi-bridge construction and after the observed damage of most of the houses in the uphill area, favoured the existence of a very superficial creep affecting however the one or two storey buildings of the summer-housing estate.

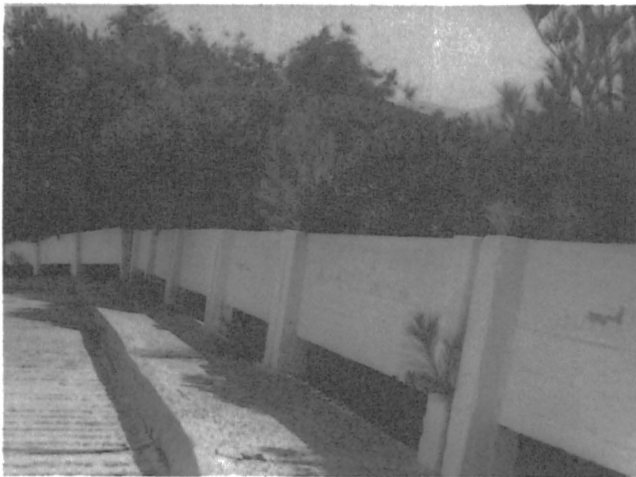
Fig. 2 Tilting of a Retaining Wall inside the "AKTEA" Estate

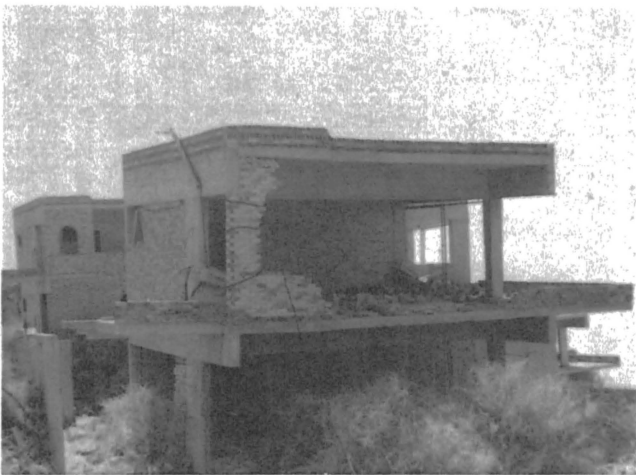
It must be noted that such sliding phenomena are easily noticeable in adjacent areas and very close to the national road as can be seen in Figure 3 where damaged and abandoned buildings due to landsliding are shown.

Fig. 3 Damaged Buildings due to Landsliding

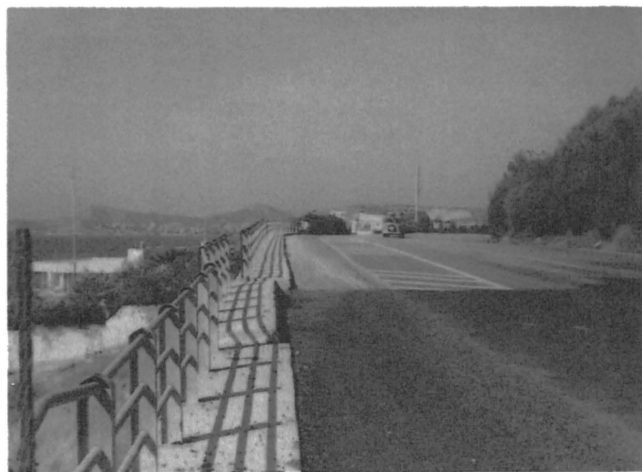
However, two years after the completion of the semi-bridge construction some cracks appeared in the road-pavement and a rather large inclination of the wing-wall of the bridge was observed as it is illustrated in Figure 6. In addition a gradual loss of alignment of the piers and an offset increasing with time was observed as it

Fig. 6 Wing-Wall Tilting and Repaired Road Pavement

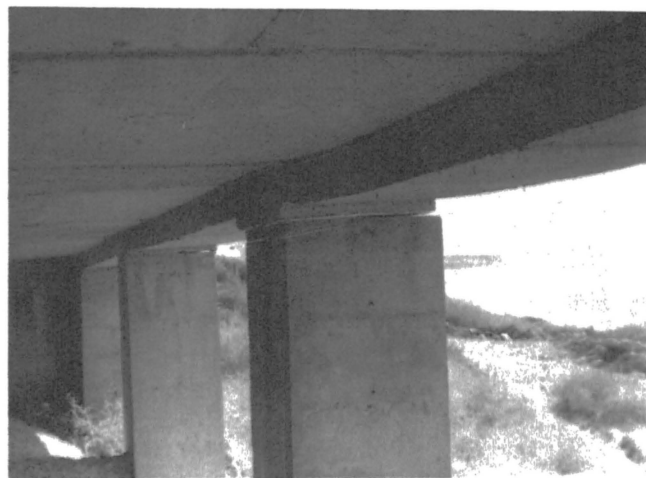
is clearly shown in Figure 7. These phenomena continued in an increasing rate and an extensive investigation program was planned and carried out

Fig. 7 Loss of Alignment of the Piers of the Semi-bridge

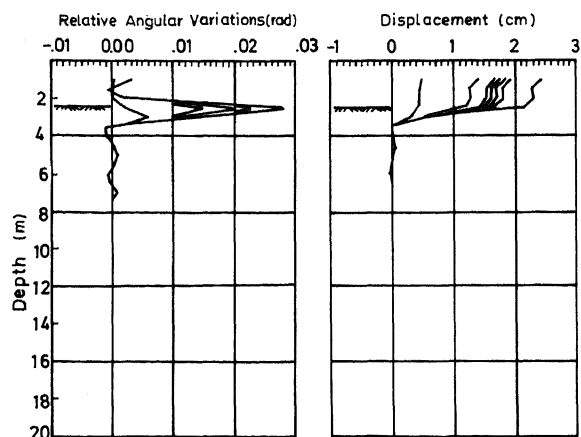
The data from the inclinometers B1, B2, B3 demonstrated conclusively that slope failure was occurring along a surface 2.5 to 4.0 metres below the foundation level of the piers of the semi-bridge and in a depth 6 - 8 m below the road level. Analyses of the inclinometer B4 data installed downhill from the semi-bridge showed the existence of a slide in a depth of 8m while data from inclinometer B5 installed uphill from the semi-bridge (Figure 1) located the slide surface in a depth of approximately 5.8 m. The mean rate of movements (total horizontal displacements) was very low, locally varying between 0.6 and 2.0 cm/year, whereas the movement direction was N5°W to N25°E, towards the coast. The movement rate varied seasonally, being greatest in spring and early summer and least during fall and winter.

Figure 9 shows the angular variation and the resulted horizontal displacement for inclinometer B2 during the period 18.4.1985 and 19.2.1987, whereas in Figure 10 the total horizontal displacement (N6°E direction) with time, is illustrated. The data from the inclinometers B6, B8 and B9, installed eastern from the semi-bridge (Figure 1) showed the same type of sliding as above in a depth of about 7.5 - 8.5 m below the surface of the new road. On the contrary, inclinometer B7 showed no evidence of sliding and so it could be considered that the location of this inclinometer is out of the limit of the observed landslide. Surface surveying which is still in progress showed a definite horizontal displacement of slope surface only in the narrow area of B6, B8 and B9 inclinometers and also a differential movement of the wing-walls of the semi-bridge.

Fig. 9 Movement of Inclinometer B2

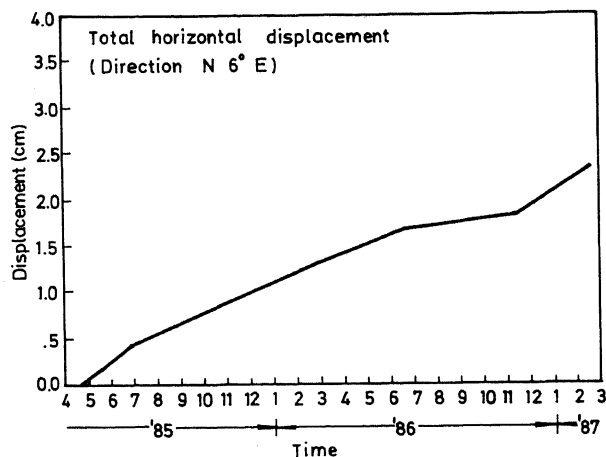
Fig. 10 Total Horizontal Displacement of Inclinometer B2 with Time

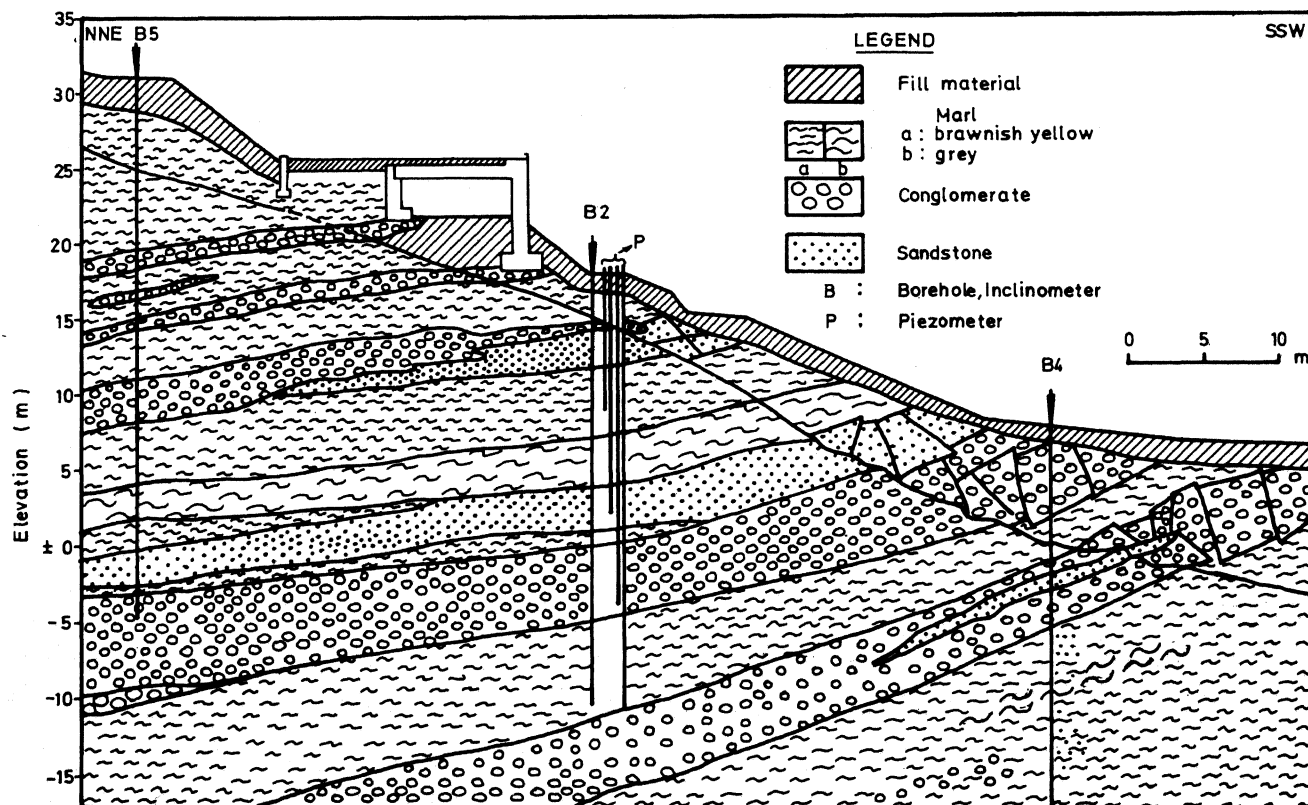
On the basis of the geological data, the logs of boreholes and inclinometers data, the geological cross section across the inclinometers B5, B2 and B4, of a direction NNE to SSW, was able to be drawn as it is illustrated in Figure 11. As is shown in this Figure the slip surface is a rather undulating one which crosses the marl layers as well as the layers of conglomerates and sandstones. It must be noted that sliding takes place

through the mass of marls, but the sliding surface follows the joints and cracks of conglomerates and sandstones which are mainly subjected to extension and not to shearing. It is believed that the structure of the conglomerates and sandstones above the sliding surface has been disturbed due probably to an old landslide.

Fig. 11 Geological Cross Section and Location of Slip Surface

Janbu (1973) and Morgenstern and Price (1965) methods of slope stability analysis were used to analyze the slip surface assuming the sliding mass to be in a state of limiting equilibrium and a piezometric grade line coincident with the sea level. Drained strength parameters of $\phi' = 14^\circ - 15^\circ$; $c' = 0$ were backfigured as the average strength acting on the slip surface producing a safety factor of unity. It must be noted that the sections analyzed were slope configurations with : a) the crest of the landslide located in the uphill area (inside the housing estate) where the main scarps are easily noticeable, and the toe close to the semi-bridge and b) the same location for the crest of the landslide but with toe located at the sea bottom and at a distance from the coast line which is found following the curvature of the slip surface drawn in Figure 11.

It is well known that some actual or potential slides can be stabilized by means of piles (piers) driven or bored into stable underlying soil. In the case of the semi-bridge considered in this article, it is expected that a drilled cantilever pier wall downhill from the semi-bridge to stabilize the slope, has the advantage of being installed without significantly decreasing slope stability during its construction. In addition such a construction seems to be particularly advantageous in that it may be constructed with the minimum of excavation. It has been observed that, excavation downhill from the national road and adjacent to the area of the semi-bridge for foundation construction of a villa resulted in a large instability of the uphill region and in severe cracks of the national road pavement. Considering that, in urban areas such "AKTEA" the rights-of-way are restricted, the authors favoured and adopted the solution of a drilled cantilever pier wall suitably instrumented for future monitoring together with a series of subsidiary measures which are now under design.
